Report of Condition, Valuation and Insurance Survey

"Fino"

Type of Vessel:	Fino 30 (Classic Sports Runabout)
Hull Number:	None found
Yard/Serial Number:	None found
Registration:	None found
Vessel Lying:	Yacht Haven Quay (dry stack), Plymouth, Devon
Owner (instructing):	Mr Nick Sprague
Address of Owner:	No Sea View, Shepherds Court, Lower Lane, Ebford, EX3 0FD
Date of Survey:	19 th June 2019

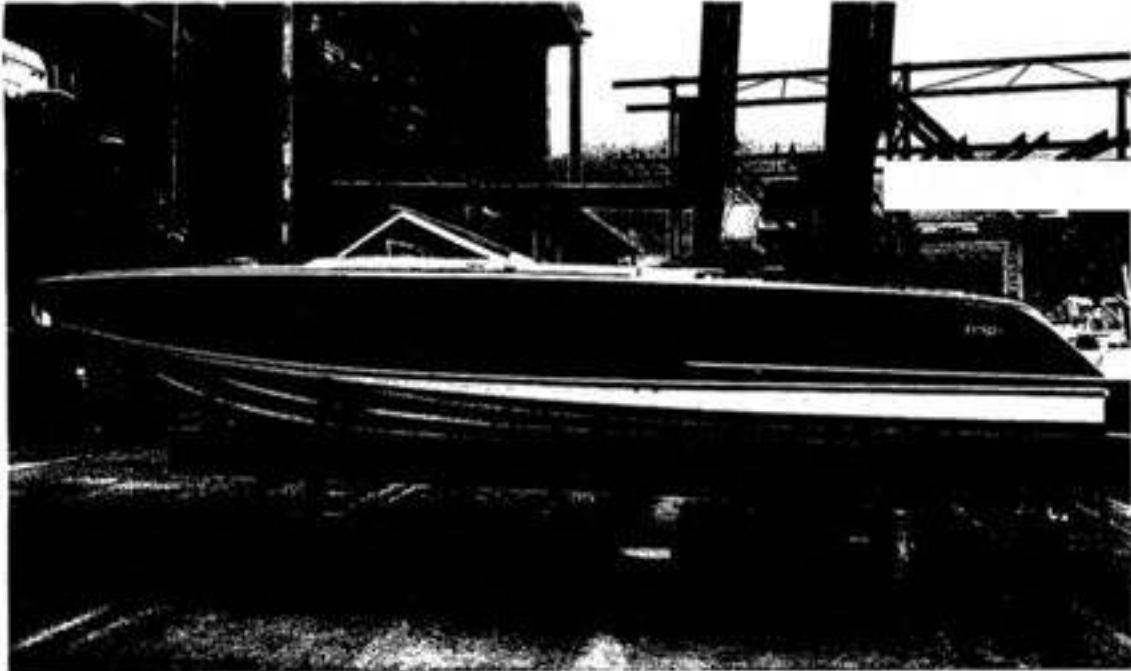
Length OA:	10.39m	30'3"
Beam:	3.40m	9'3"
Draft (max):	0.92m	2'9"
Builder:	Fino Marine, USA	
Designer:	Walt Walters	
Year of construction:	c1970	
Engine:	Twin Mercury inboard V8 petrol	
Accommodation:	2 berths in forward cabin.
